**Bureau of Mines and Mine Safety
Final Report
Date: August 18th, 2014
Fatality Report From
March 25th, 2014
Gibson County Coal LLC
Gibson Mine
Prepared by Donald "Blink" McCorkle
Assistant Commissioner**

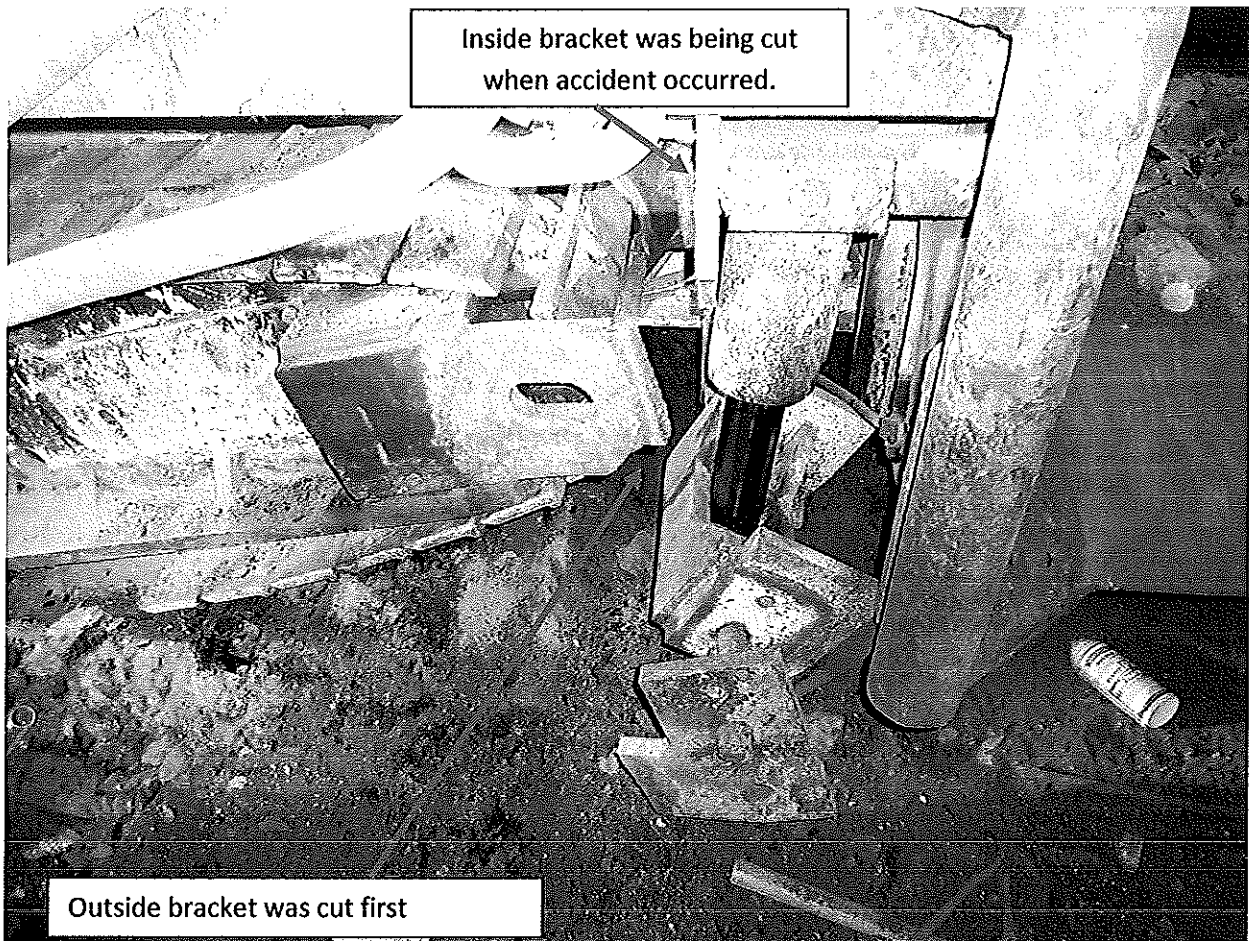
Inside bracket was being cut
when accident occurred.

Outside bracket was cut first

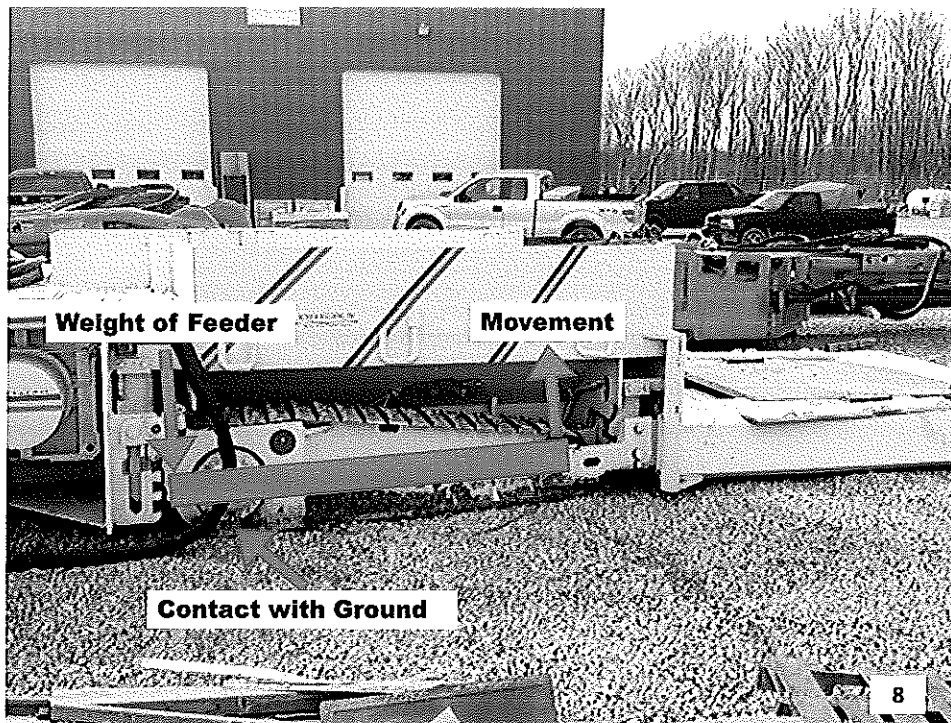
Figure 5

After Memmer and Horton arrived on the unit they set a welder and torches to repair the feeder. They moved the feeder to the inby intersection to have more working space around the feeder. (See accident area diagram showing feeder moved from the belt tail to the intersection.) Horton positioned the feeder in the intersection then actuated the lift cylinders to elevate the hopper end of the feeder (see diagram #5). Memmer, Horton, and Steve Waldern, Mechanic, then built a crib underneath the center of the hopper end of the feeder to block the hopper. (See accident area diagram and figure #5 for location of hopper.)
